Home Report

2 REAY STREET
INVERNESS
IV2 3AJ

**Walker Fraser Steele
Chartered Surveyors**

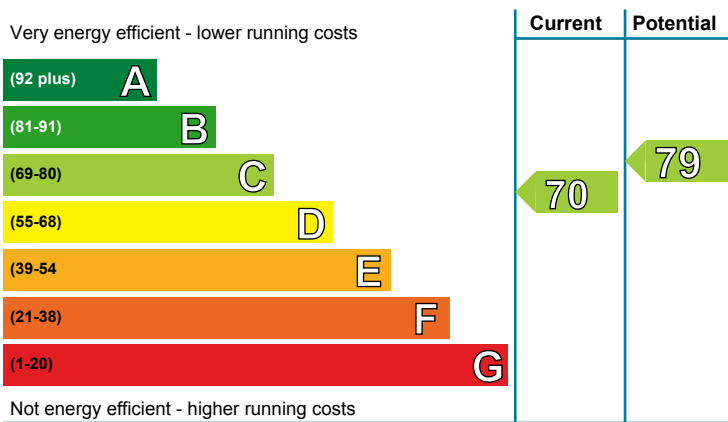
Energy Efficiency Rating

This graph shows the current efficiency of your home, taking into account both energy efficiency and fuel costs. The higher this rating, the lower your fuel bills are likely to be.

Your current rating is **band C (70)**. The average rating for EPCs in Scotland is **band D (61)**.

The potential rating shows the effect of undertaking all of the improvement measures listed within your recommendations report.
